BGC Project Memorandum

То:	Town of Canmore	Doc. No.:	TC13-008
Attention:	Andy Esarte, P.Eng	cc:	Blair Birch, P.Eng.
From:	Matthias Jakob	Date:	December 2, 2013
Subject:	X, Y, and Z Creeks, Forensic Analysis – FINAL		
Project No.:	1261-001

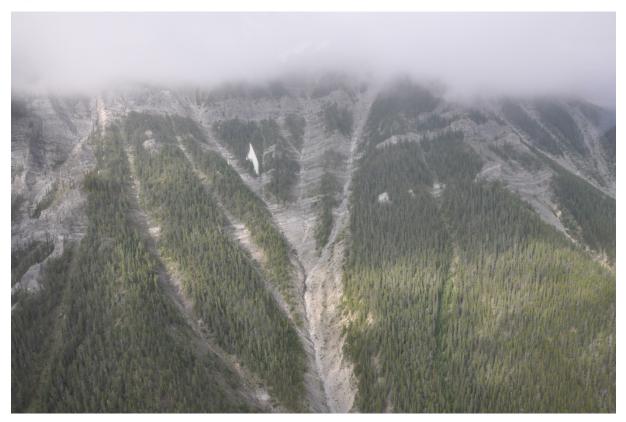
The watersheds of X, Y, Z Creeks are characterized by limited sediment sources which is due partially due to relative low rates of weathering and rock fall production and partially due to the fact that frequent snow avalanches likely transport lose debris to lower elevations (Photo 3-1 and Photo 3-2). This supply limitation reduces the possible amount of debris that can be entrained in debris flows unless debris is derived from deep fan scour. Deep fan scour has been observed in some cases on creeks in the Canmore area, but it is impossible to predict its likelihood and location.

Photo 3-1. Overview of X Creek watershed showing a dendritic channel network characterized by a high frequency of snow avalanches that will likely displace much of the loose debris to lower watershed elevations. This watershed has a high runoff coefficient and will thus convey stormwater rapidly into the lower channel system where it may evolve into a debris flow. BGC photograph of July 23, 2013.

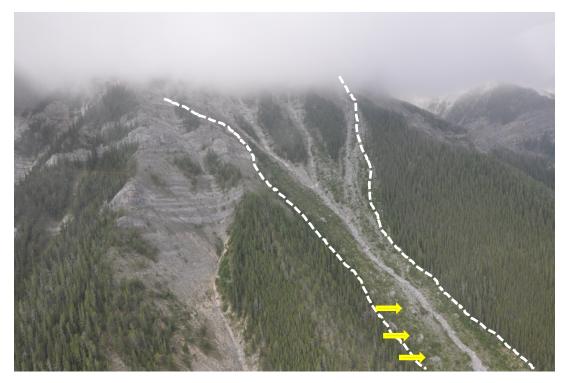
Photo 3-2. Aerial view of Y Creek showing a well pronounced avalanche path (delineated in white dashed lines) and several very large rock fall boulders (arrows). This channel has significantly more debris storage than X Creek and could thus produce larger debris flows. BGC photograph of July 23, 2013.

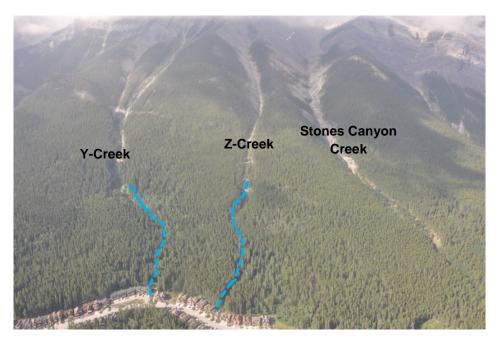
Photo 3-3. Overview of Y and Z Creeks upslope of the Peaks of Grassi subdivision, which is located on the distal fan. The creek outlines are approximate. BGC photograph of July 23, 2013.

X, Y and Z Creeks reach their fan apex between approximately 1500 and 1600 m from where they spread into their respective fans. Given their close proximity, the fan areas of Y and Z Creeks have merged (Photo 3-3). It is unclear at this point if channel avulsions could occur in the upper fan reaches of X, Y and Z Creeks which could significantly increase the amount of available water in any of these creeks leading to more severe flooding and scour in their downstream channel reaches. This potential should be investigated as part of a more detailed hazard investigation.

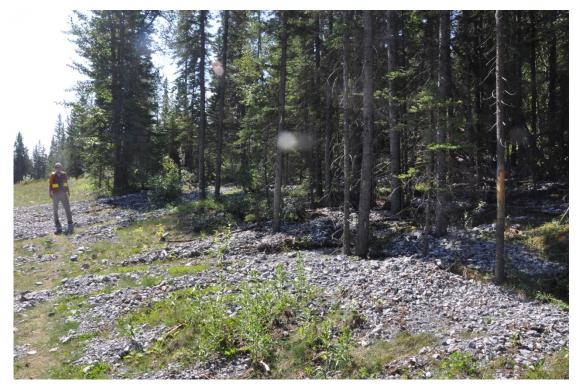
The distal fan margins of Y Creek and Z Creek are currently mapped as encroaching on existing development along Wilson Way: four buildings on Y Creek and 20 buildings on Z Creek. However, it should be stressed that the fan margins end on ice marginal (kame) terrace features and, therefore, it is very difficult to delineate the fan boundaries precisely based on topographic information alone. The fan aggradation processes also mask the dominant channel which can easily shift during or immediately following debris flow events. When reaching the Peaks of Grassi subdivision, flows are believed to be very thin (less than 30 cm) and largely unchannelized. Photo 3-4 is an example of a thin debris flow deposit on X Creek associated with the June 2013 event.

Photo 3-4. Recent (June 19-21, 2013) debris-flow event on X Creek. Flows on Y and Z Creek are believed to be similar in appearance by the time they reach the Peaks of Grassi development. BGC photograph of July 25, 2013.

As illustrated by Photo 3-4, a debris flow did occur on X Creek during the June 19-21, 2013 period. Photo 4-1 is an aerial view of the watershed, on which the debris-flow path is evident. Fortunately development on the fan of X Creek is limited and BGC is not aware of any damage incurred.

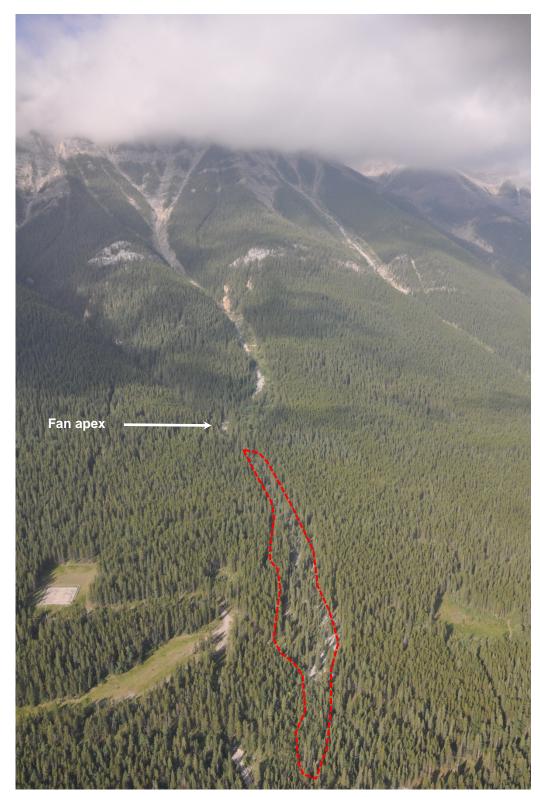
Photo 4-1. Aerial view looking south of the X Creek watershed. The approximate depositional zone of the June 2013 debris flow is delineated by the red dashed line. BGC photograph of July 23, 2013.

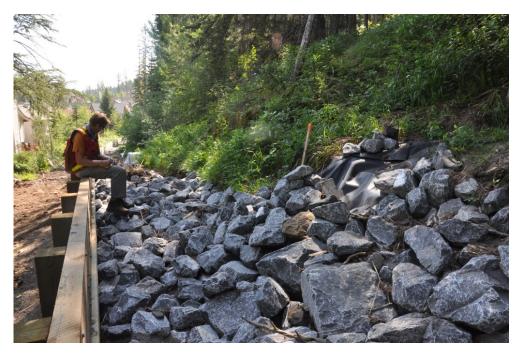
On July 13, 2012, a heavy rainstorm in the watershed resulted in overland flooding to the usually dry stream channels above Wilson Way (Town of Canmore, 2012). The longest diversion structure shown on Drawing 4 was not long enough to capture all of the flow, however, and this resulted in the flooding of several yards. Residents worked to direct the flows between homes to minimize damage to the structures and prevent basement flooding. Because of the volume of water and steep grades, a large quantity of landscape material was washed from the yards and onto the street where it was carried to downstream manholes. The manholes plugged, resulting in flooding of the street. Following this event, the existing lined and riprapped channel that is diverted by wooden posts and beams was extended by about 40 m to protect an additional five homes (Photo 4-2 and Photo 4-3).

Photo 4-2. Lined and riprapped interception channel on Y Creek above Wilson Way. The riprap and liner were placed following the July 2012 storm. BGC photograph of July 25, 2013.

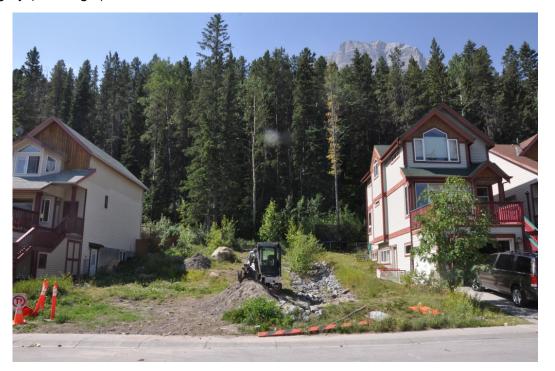
Photo 4-3. Photograph along Wilson Way looking upstream. One lot was left unoccupied to allow water flow in the riprapped channel which then enters a culvert below Wilson Way. BGC photograph of July 25, 2013.

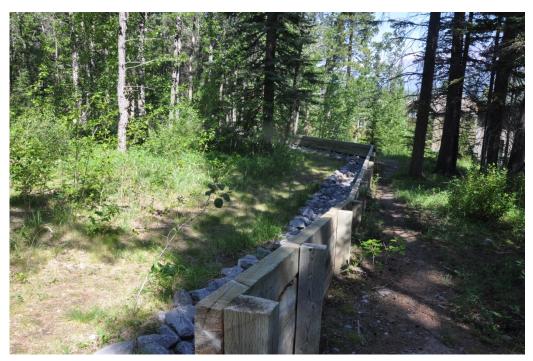
Additional wooden deflection barriers have been constructed at Y and Z Creeks. At the two locations shown on Drawing 4, short wooden barriers about 1 m high have been constructed in a V-shaped pattern. The walls are about 25 to 30 m in length and the intent is to convey

overland flow into a shallow, riprap-lined channel about 2 m wide (Photo 4-4). The riprapped channels are about 50 m to 60 m in length and discharge into grated, drop culverts underneath Wilson Way (Photo 4-5). Both walls are located where one might expect overland flows from Y Creek and Z Creek to discharge (based on aerial images); however, BGC did not observe an incised or identifiable channel upslope of either of the V-shaped wooden walls. There are also no easily identifiable channels observed on the LiDAR imagery (Drawing 2) for these two creeks.

Photo 4-4. V-shaped, deflection wall installed upstream of development on Wilson Way. This structure is located along Y Creek, although no identifiable channel was observed upslope of the wall. BGC photograph of July 25, 2013.

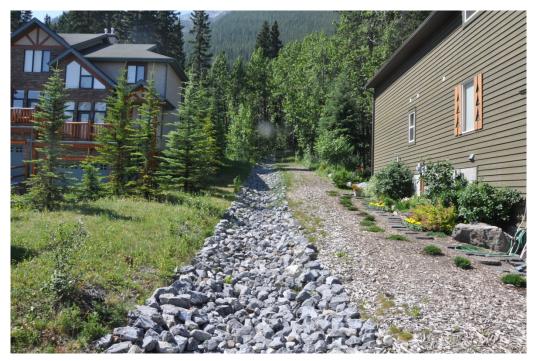
Photo 4-5. Upstream view of riprapped channel installed downstream of the V-shaped wooden wall shown on Photo 4-4. BGC photograph of July 25, 2013.

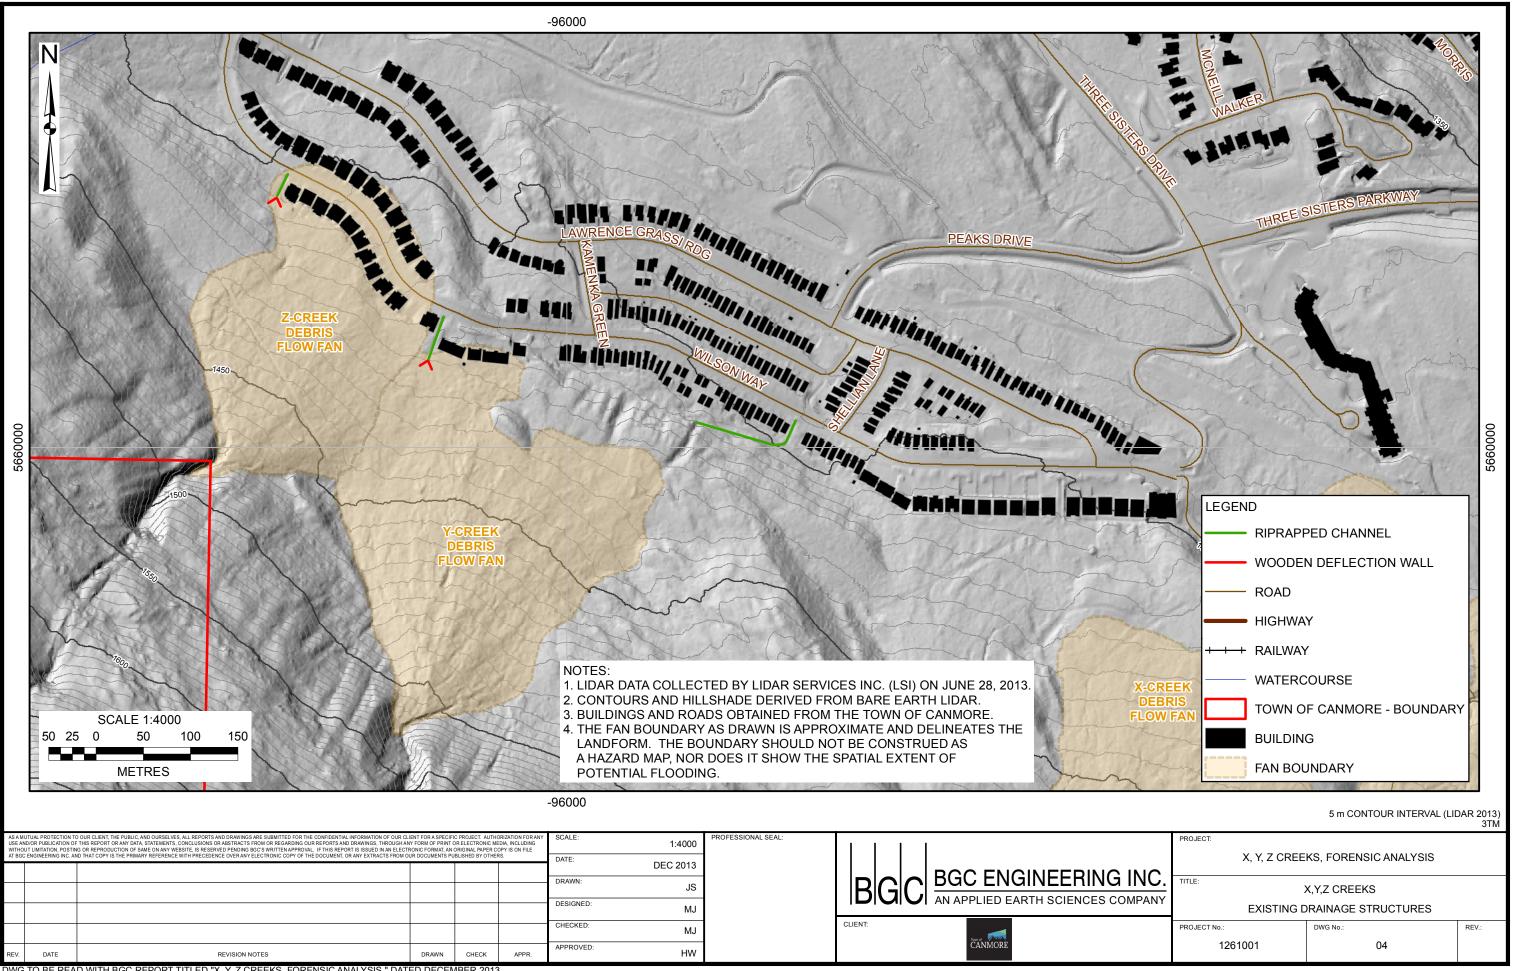
EXISTING DRAINAGE STRUCTURES			
PROJECT No.:	DWG No.:	REV.:	
1261001	04

It is currently unknown whether a debris flow occurred on the upper fan reaches of Y Creek during the June 19-21, 2013 storm. However, overland flooding has occurred in the past. The original subdivision design included wooden drainage diversion structures and riprapped channels to manage flash flood flows and divert them safely into existing storm water management infrastructure. The approximate extents of these structures are delineated on Drawing 4.

However, as mapped, the distal fan margins of Y and Z Creek do encroach on existing housing. The present study aimed to determine damages of the June 2013 hydroclimatic event and provide some initial commentary on hazard analysis. It does not replace more detailed investigations to support the development of detailed hazard maps and specific mitigation measures for low frequency events. Therefore, BGC recommends that Y and Z Creek channels be traversed individually at least to the respective fan apexes and old debris flow deposits mapped via a GPS unit. Following this traverse, a limited number of shallow (2 m) test trenches should be excavated along existing trails (to avoid excessive ground disturbance) immediately upstream of the existing development to determine if larger (thicker) and thus more destructive flows have occurred in the past and can be identified as the surface units. Should such flows be identified during test trenching, the Town may contemplate a detailed hazard and risk assessment that would include more rigorous test trenching, dendrochronology and numerical debris flow modelling. Field checking of potential drainage paths is also recommended as such channels may approach the resolution of the LiDAR imagery. There may be benefit in installing additional structures such as identified on Drawing 4.

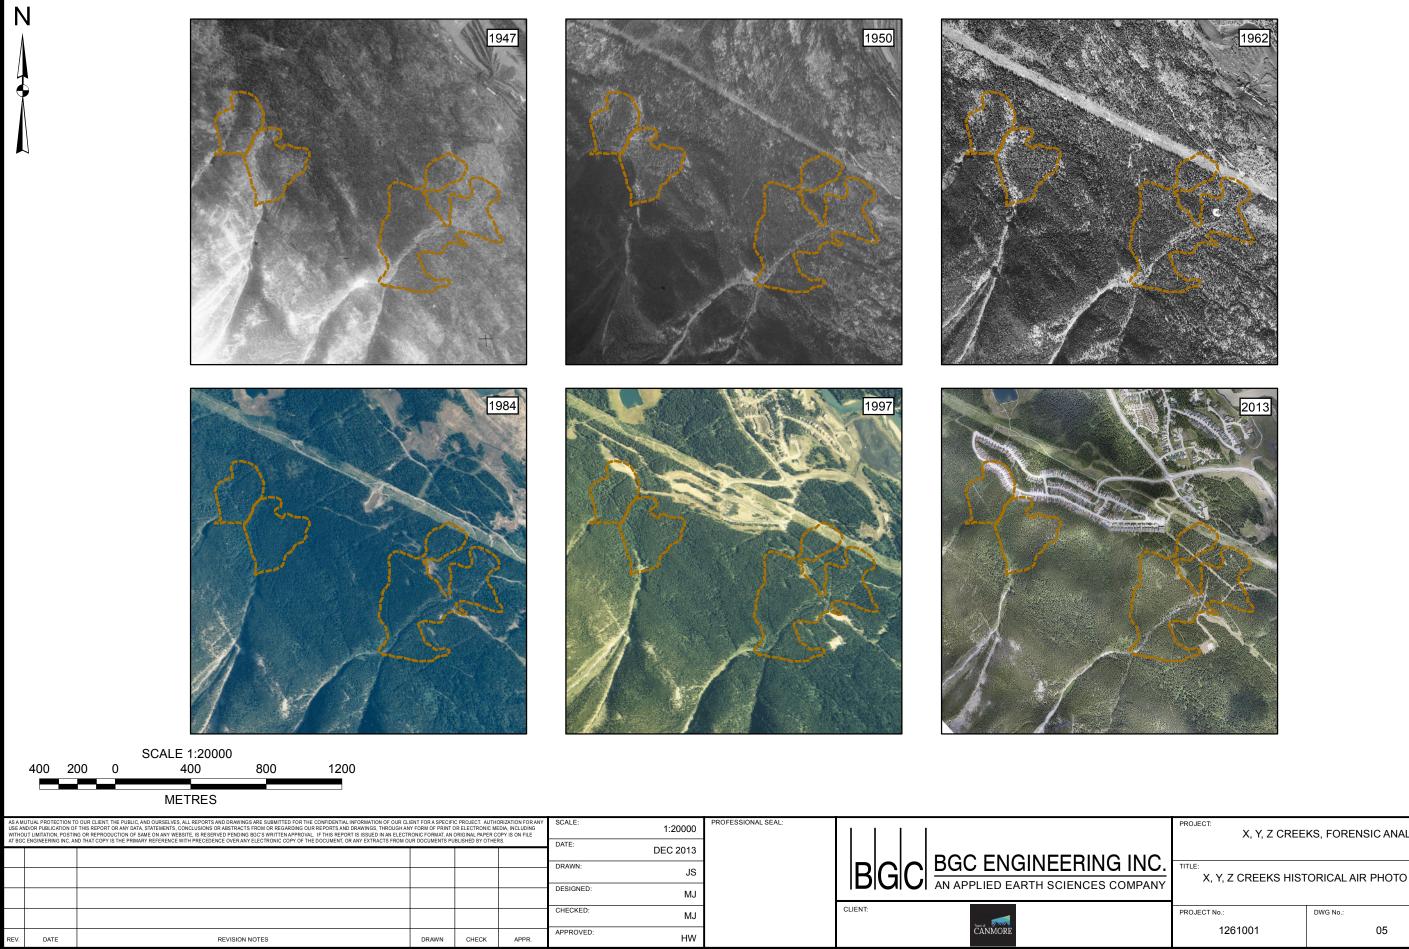
X, Y, Z CREEKS, FORENSIC ANALYSIS X, Y, Z CREEKS HISTORICAL AIR PHOTO COMPARISON REV.:

The air photo review indicates a general lack of obvious debris flow activity on Y and Z Creeks between 1947 and 2013. A swath of a lighter shade of vegetation is apparent on the 1947, 1950 and 1962 air photos on the west edge of both fans (Drawing 5). This vegetation is most obvious on the 1962 air photographs and may represent an older debris flow path that was re-vegetated by deciduous trees. The debris flow path of the 2013 event on X Creek is obvious on the orthophoto (Drawing 5) and the older air photos indicate that debris flows in the last century have also followed this alignment.

These observations support the supposition that small debris flows with decadal frequency occur on X, Y, Z creeks with magnitudes in the hundreds and perhaps low thousand cubic meters. A better specification of frequencies and magnitudes with more extensive records could be achieved through a dendrochronologic study.
