Quarry Pines

**Water Courses**

Water draining downhill from the Ships Prow on Mount Lawrence Grassi does  
not end up in Quarry Lake

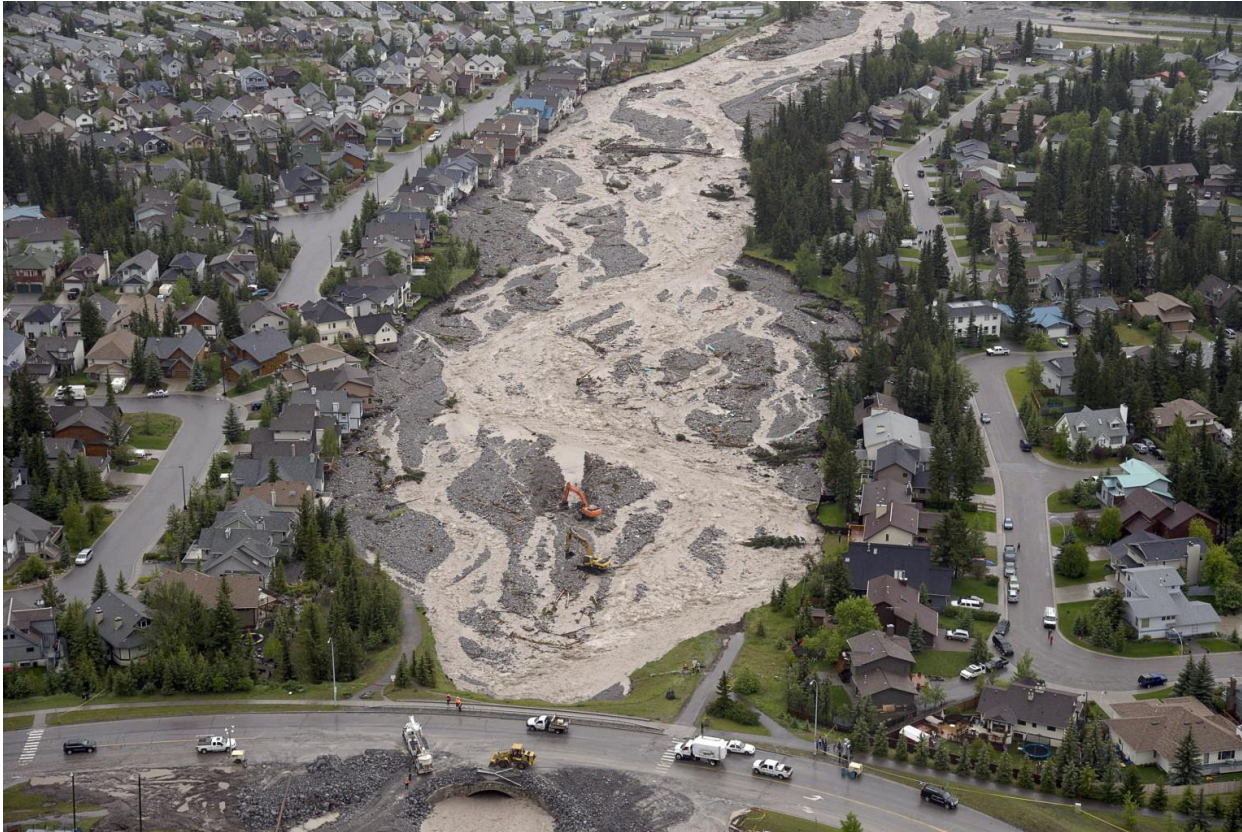
We understand now that the manner in which the Cougar Creek subdivision was designed did not address *potential* water flows in that area.

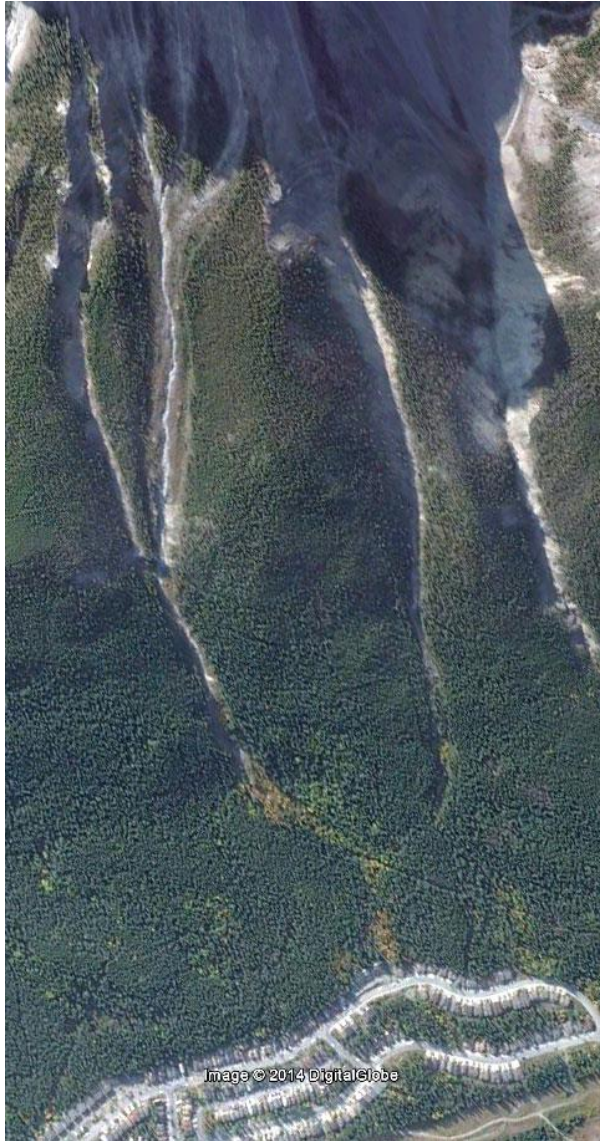
# Drainages – Aerial View

- Three drainages (X,Y and Z) off the Ship's Prow join 180m above the nearest home in the Quarry Pines then tumble across an alluvial fan to a man-made swale installed about ten years ago on the SW side of the street along Wilson Way.
- Water is intended by design to cascade down that swale to the street, then continue downhill through the "Municipal/Urban Reserve" all the way to Lawrence Grassi Ridge.
- Water then follows the natural lie of that road to the lowest point in the community, and then drain away downhill and continue its journey toward the Bow River further down in the valley.

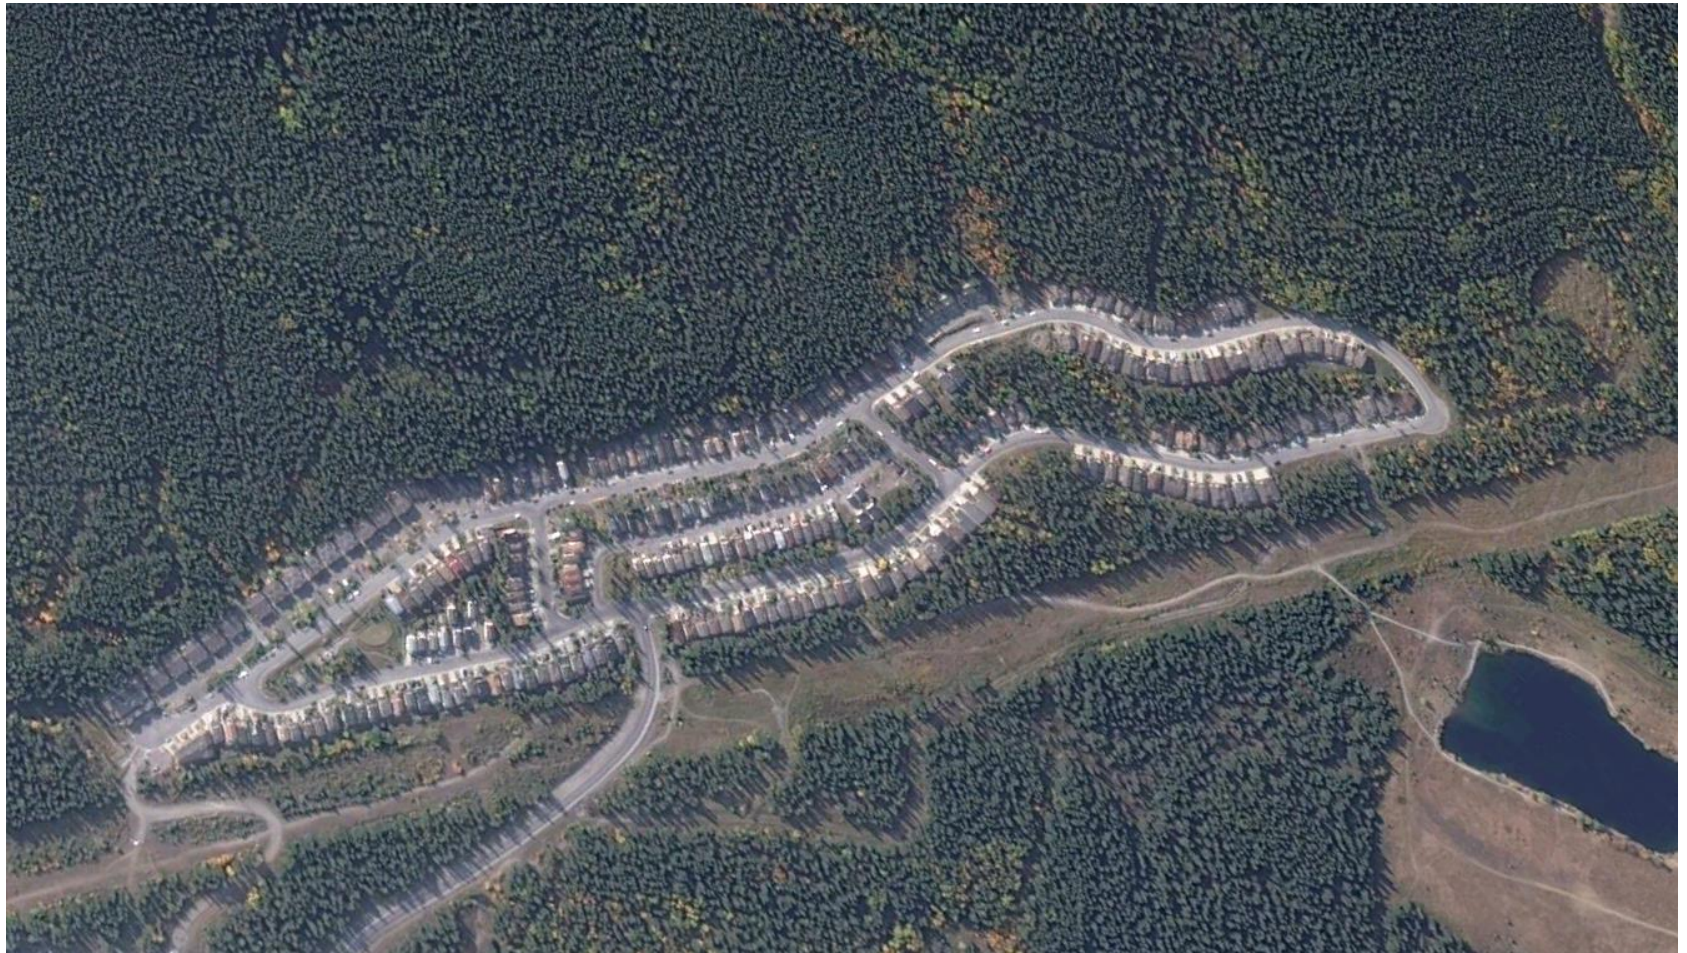
# POG and QP

June 2013 rain event caused neighbourhood Swales to wash full of water and carry debris across the roads.

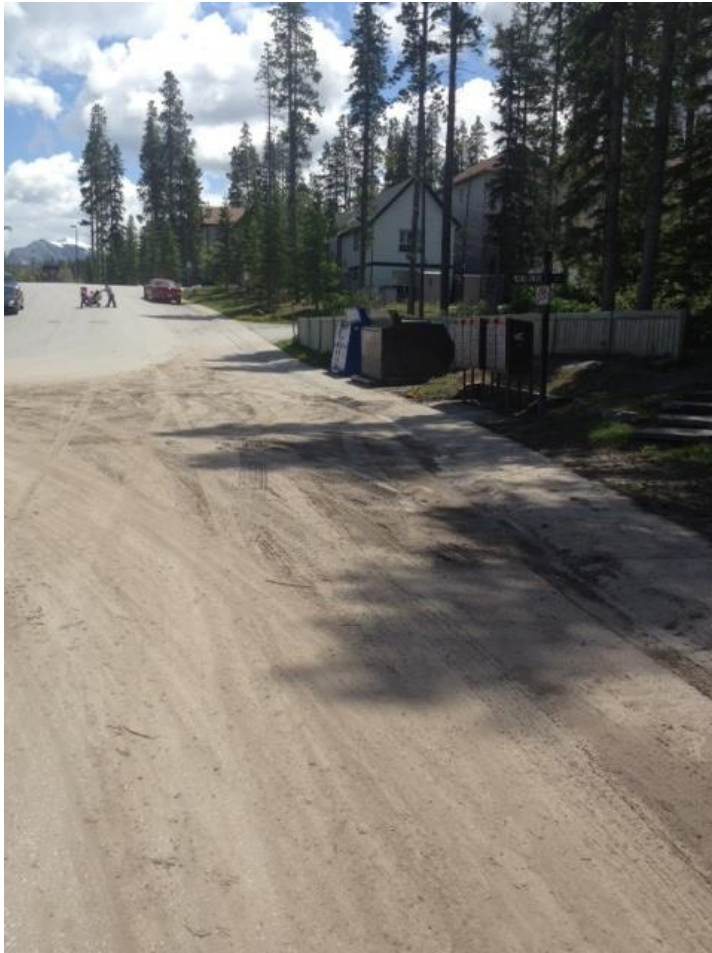
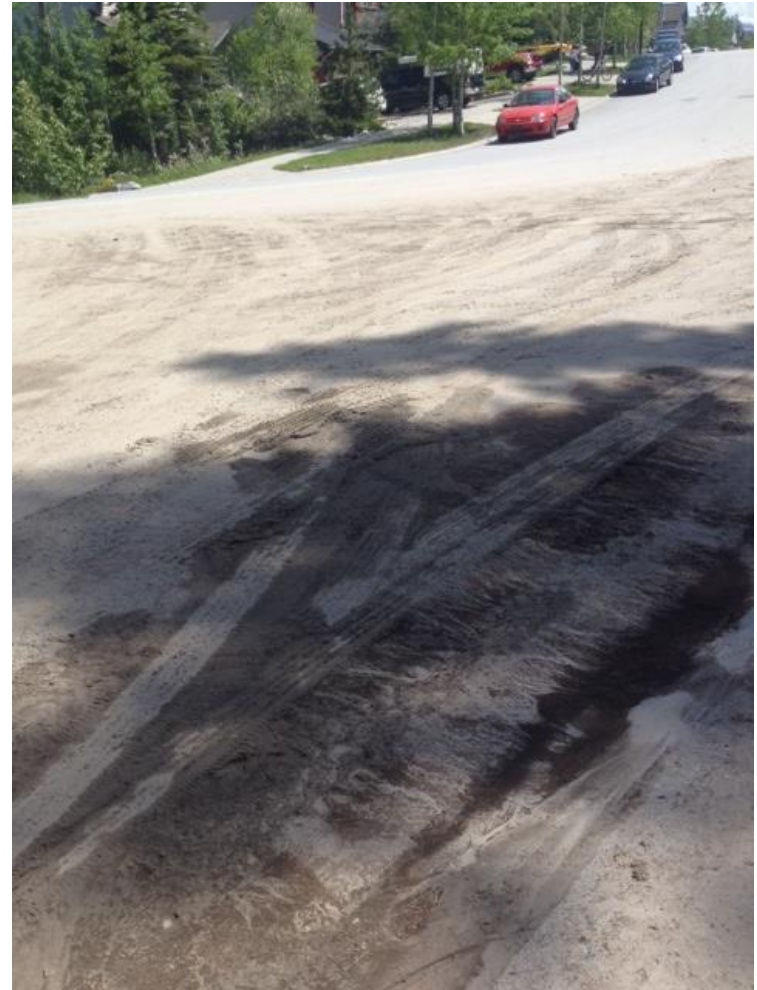
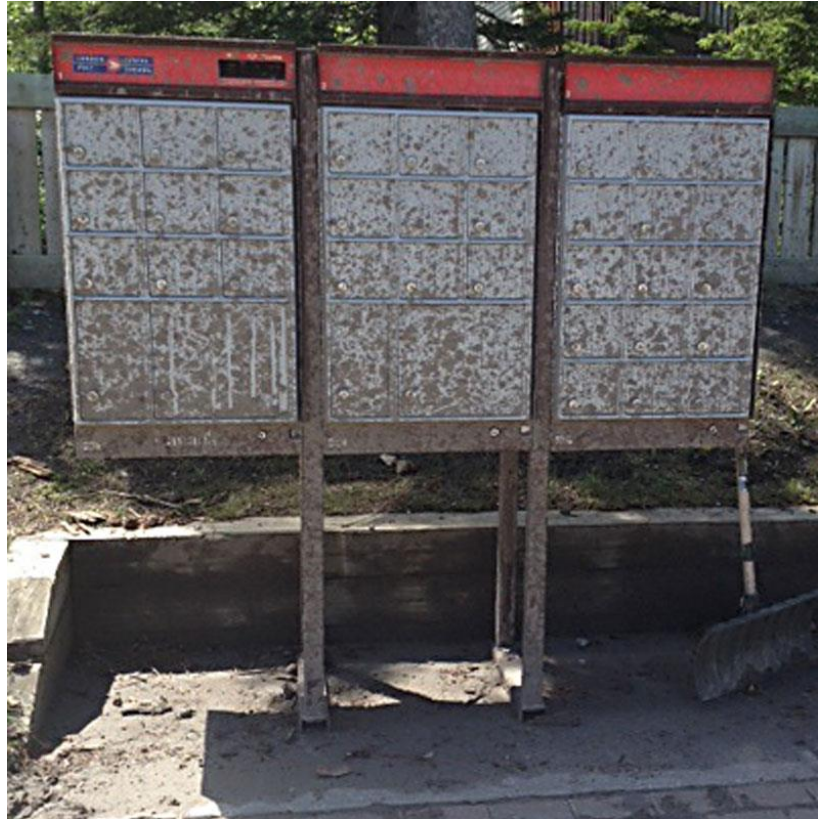
The mud splashed onto these mailboxes, happened when one of the swales in the middle of the community was overwhelmed during rain event in June 2013.

During that rain, a waterfall developed right through the middle of POG. The area pictured to the right was buried in mud and debris, and needed to be shoveled clear by residents after the rain stopped.

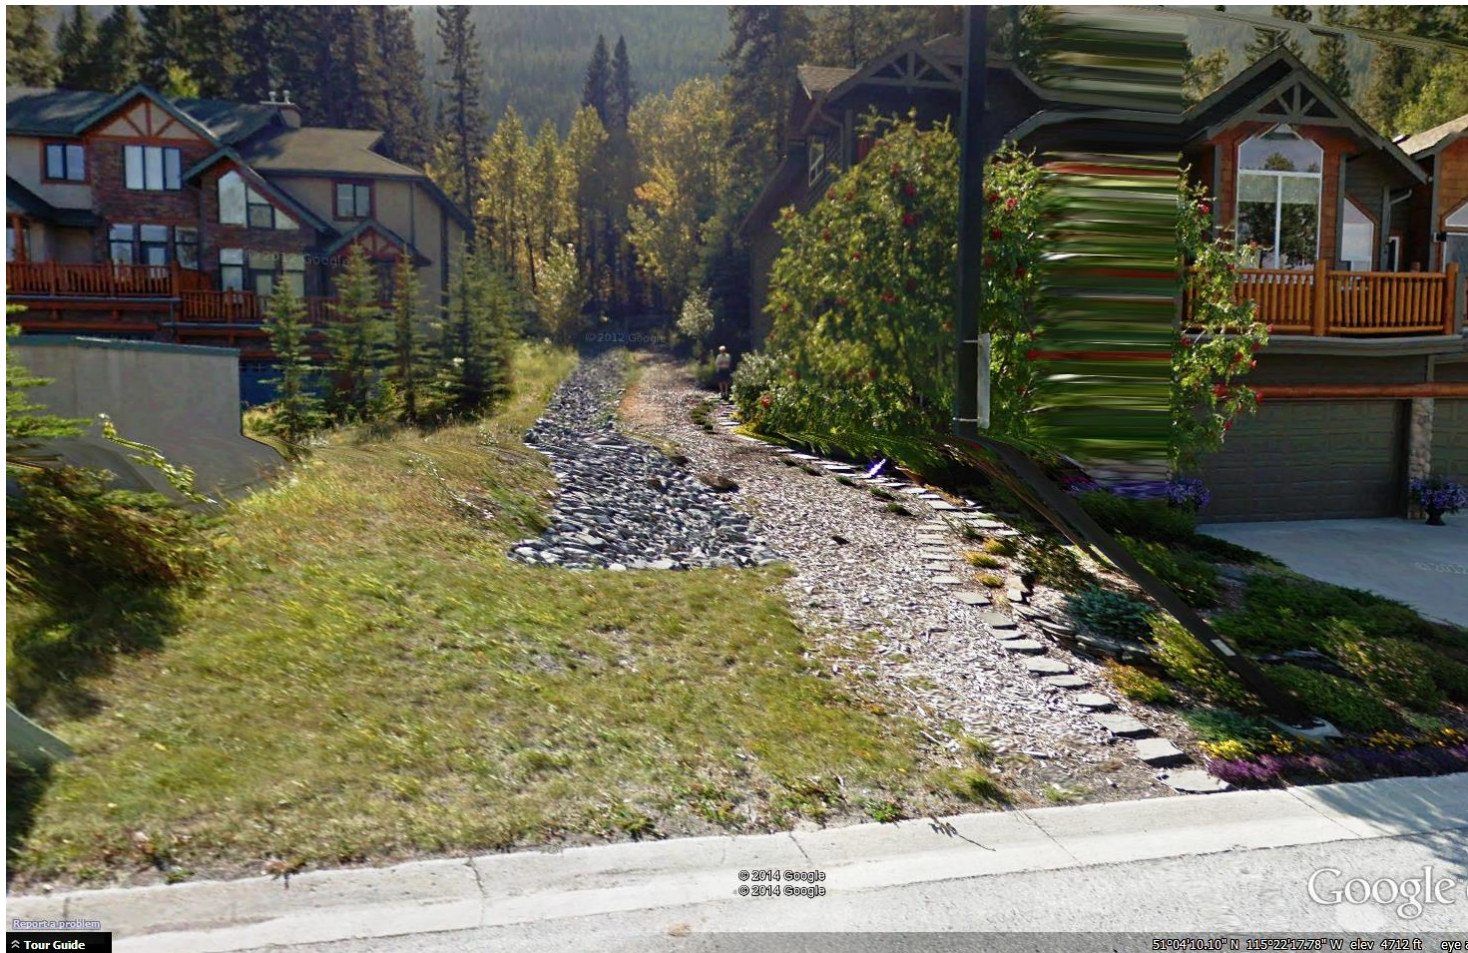
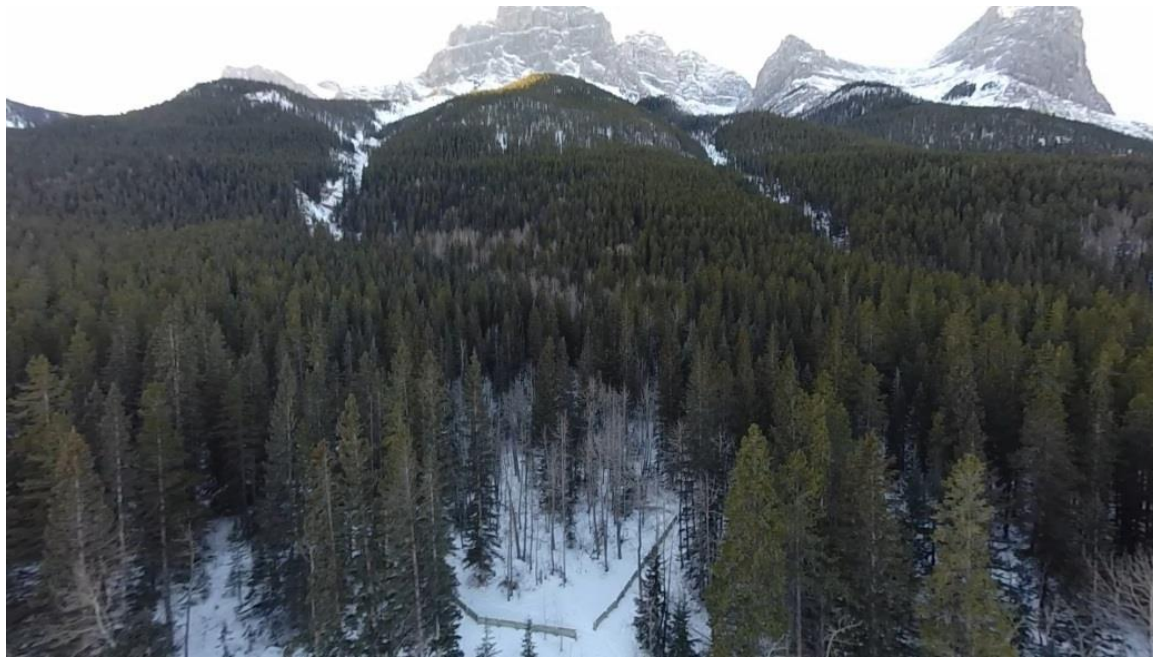
# QP Swale above 1021 Wilson Way (Across from MR and ER)

- During the last ten years it has seldom filled with water, but the drainage to its immediate southeast did fill (X Creek), and water, rocks and brush were washed across streets, and down alleyways creating a dramatic flow at the same time the flooding of Cougar Creek was occurring on the other side of the valley.

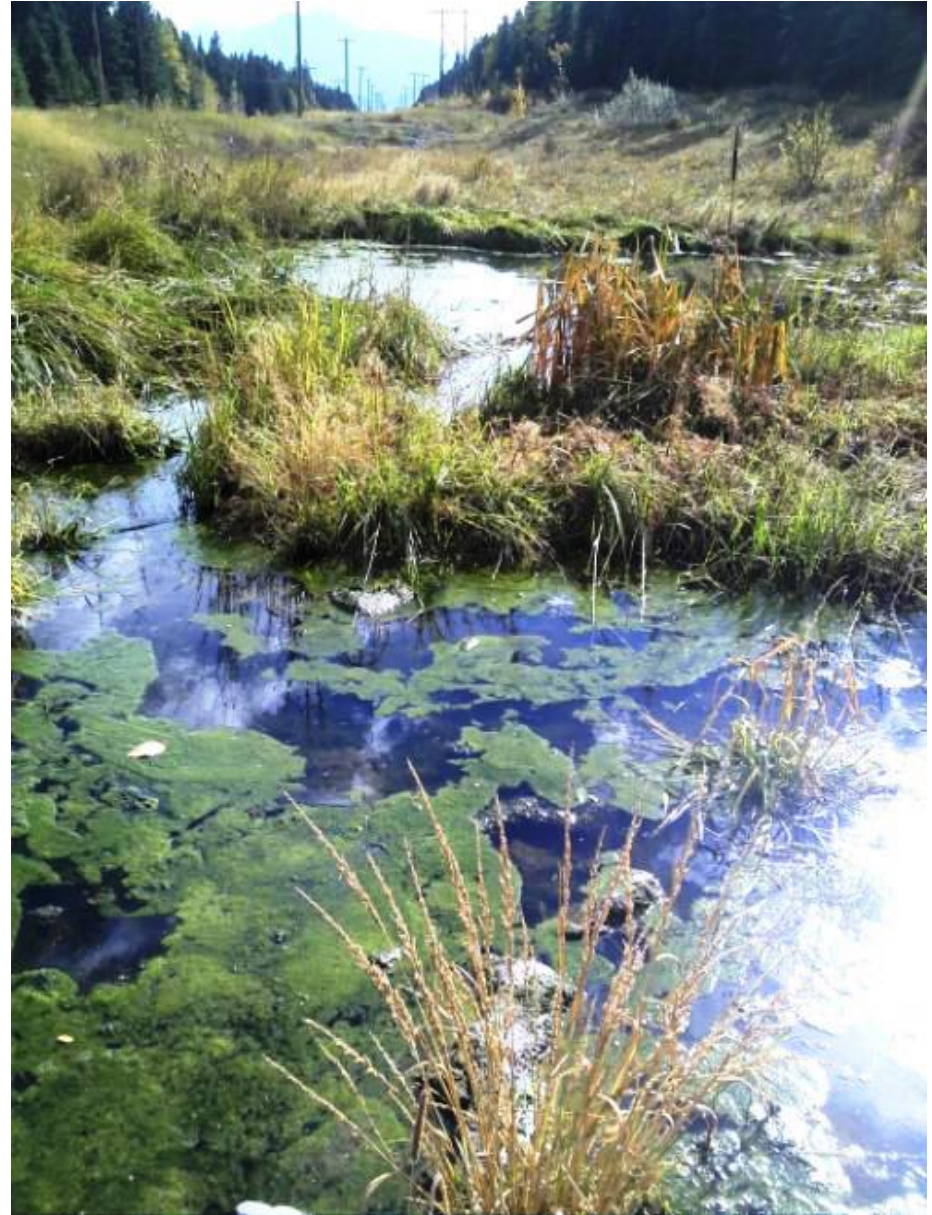
# Collected Water from Overland drainage

The image to the right is taken from the Environmental Brief created by Corivdae Environmental Consulting for the Quantum Place subdivision proposal. It is not merely an aquatic habitat, rather a structure designed to slow the movement of water cascading downhill.

There are additional structures that channel water away from this site when these collection areas fill.

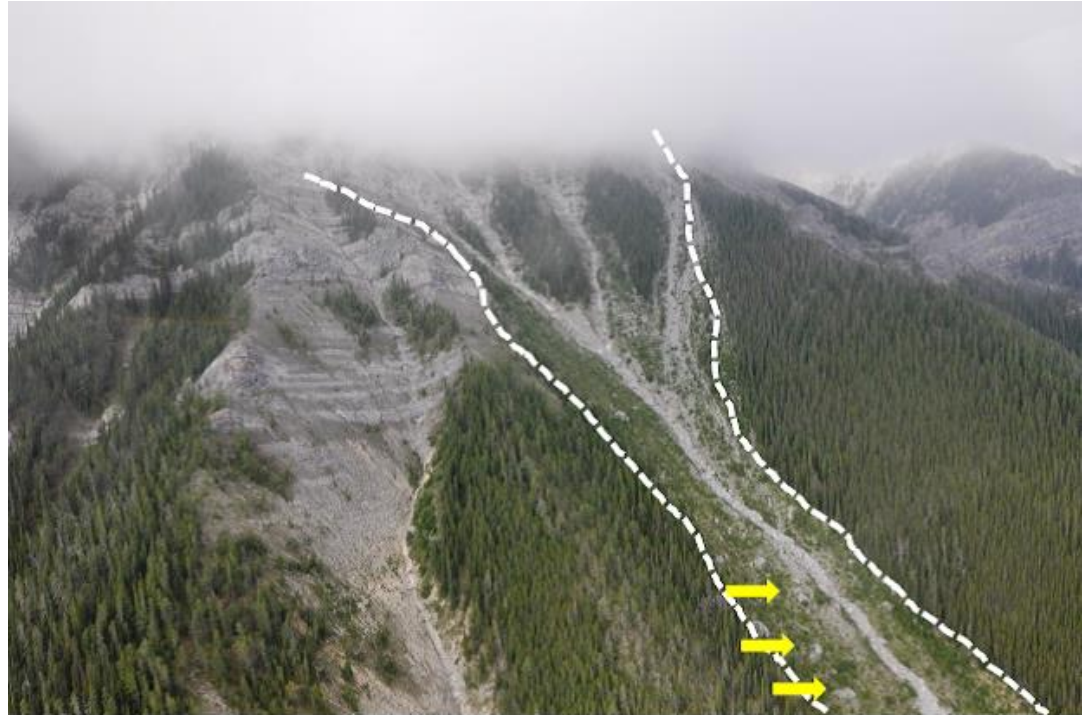
(BGC Photograph of July 23 2013)

“Aerial view of “Y” creek showing a well pronounced avalanche path (deliniated in white dashed lines) and several very large rock-fall boulders (arrows). **This channel has significantly more debris storage than “X” creek and could thus produce larger debris flows.**”
